FIELD INSPECTION REPORT

Project Name:	Mountain Valley Pipeline	Inspector:	Matthew Grant			
Inspection Date:	Tuesday, July 14, 2020	Project Contact:	Brian Clauto			
Spread G: Giles	AR GI-243.01, 249.01, 256.02, 025 ATWS 1464, 1370, 1370A MP 211.5, 212.4, 214.5, 215	Weather:	Dry			
ACTIVE STAG	E OF CONSTRUCTION: (Check all tha	ıt apply)				
☐ Tree Felling	☐ Clearing/Grubbing ☐ Gr	ading \square Trenc	hing \Box	Str	inging/Welding	
☐ Lowering/Backfilling	☐ Final Grading ☐ Te	mp. Stabilization	. Stabilization 🗵	Do	rmant	
			Yes	No	N/A	
Are controls installed and implemented in accordance with the approved erosion and sediment control plan and stormwater management plans?						
Are all control measures properly maintained in effective operating condition in accordance with good engineering practices and, where applicable, manufacturer specifications?

FIELD INSPECTION PHOTO LOG

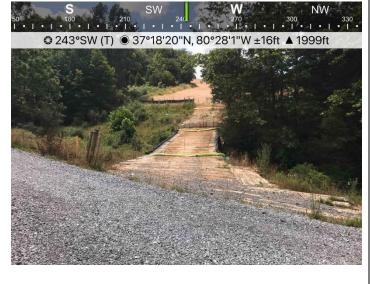
<u>Figure 4</u>: Designated stream S-NN12, ECD's are in place.
